# Resource Conservation and Recovery Act Post-Closure Care Permit Application

For U.S.D.O.E -Rocky Flats Plant  
Hazardous & Radioactive Mixed Wastes

Volume XV

**ROCKWELL INTERNATIONAL**

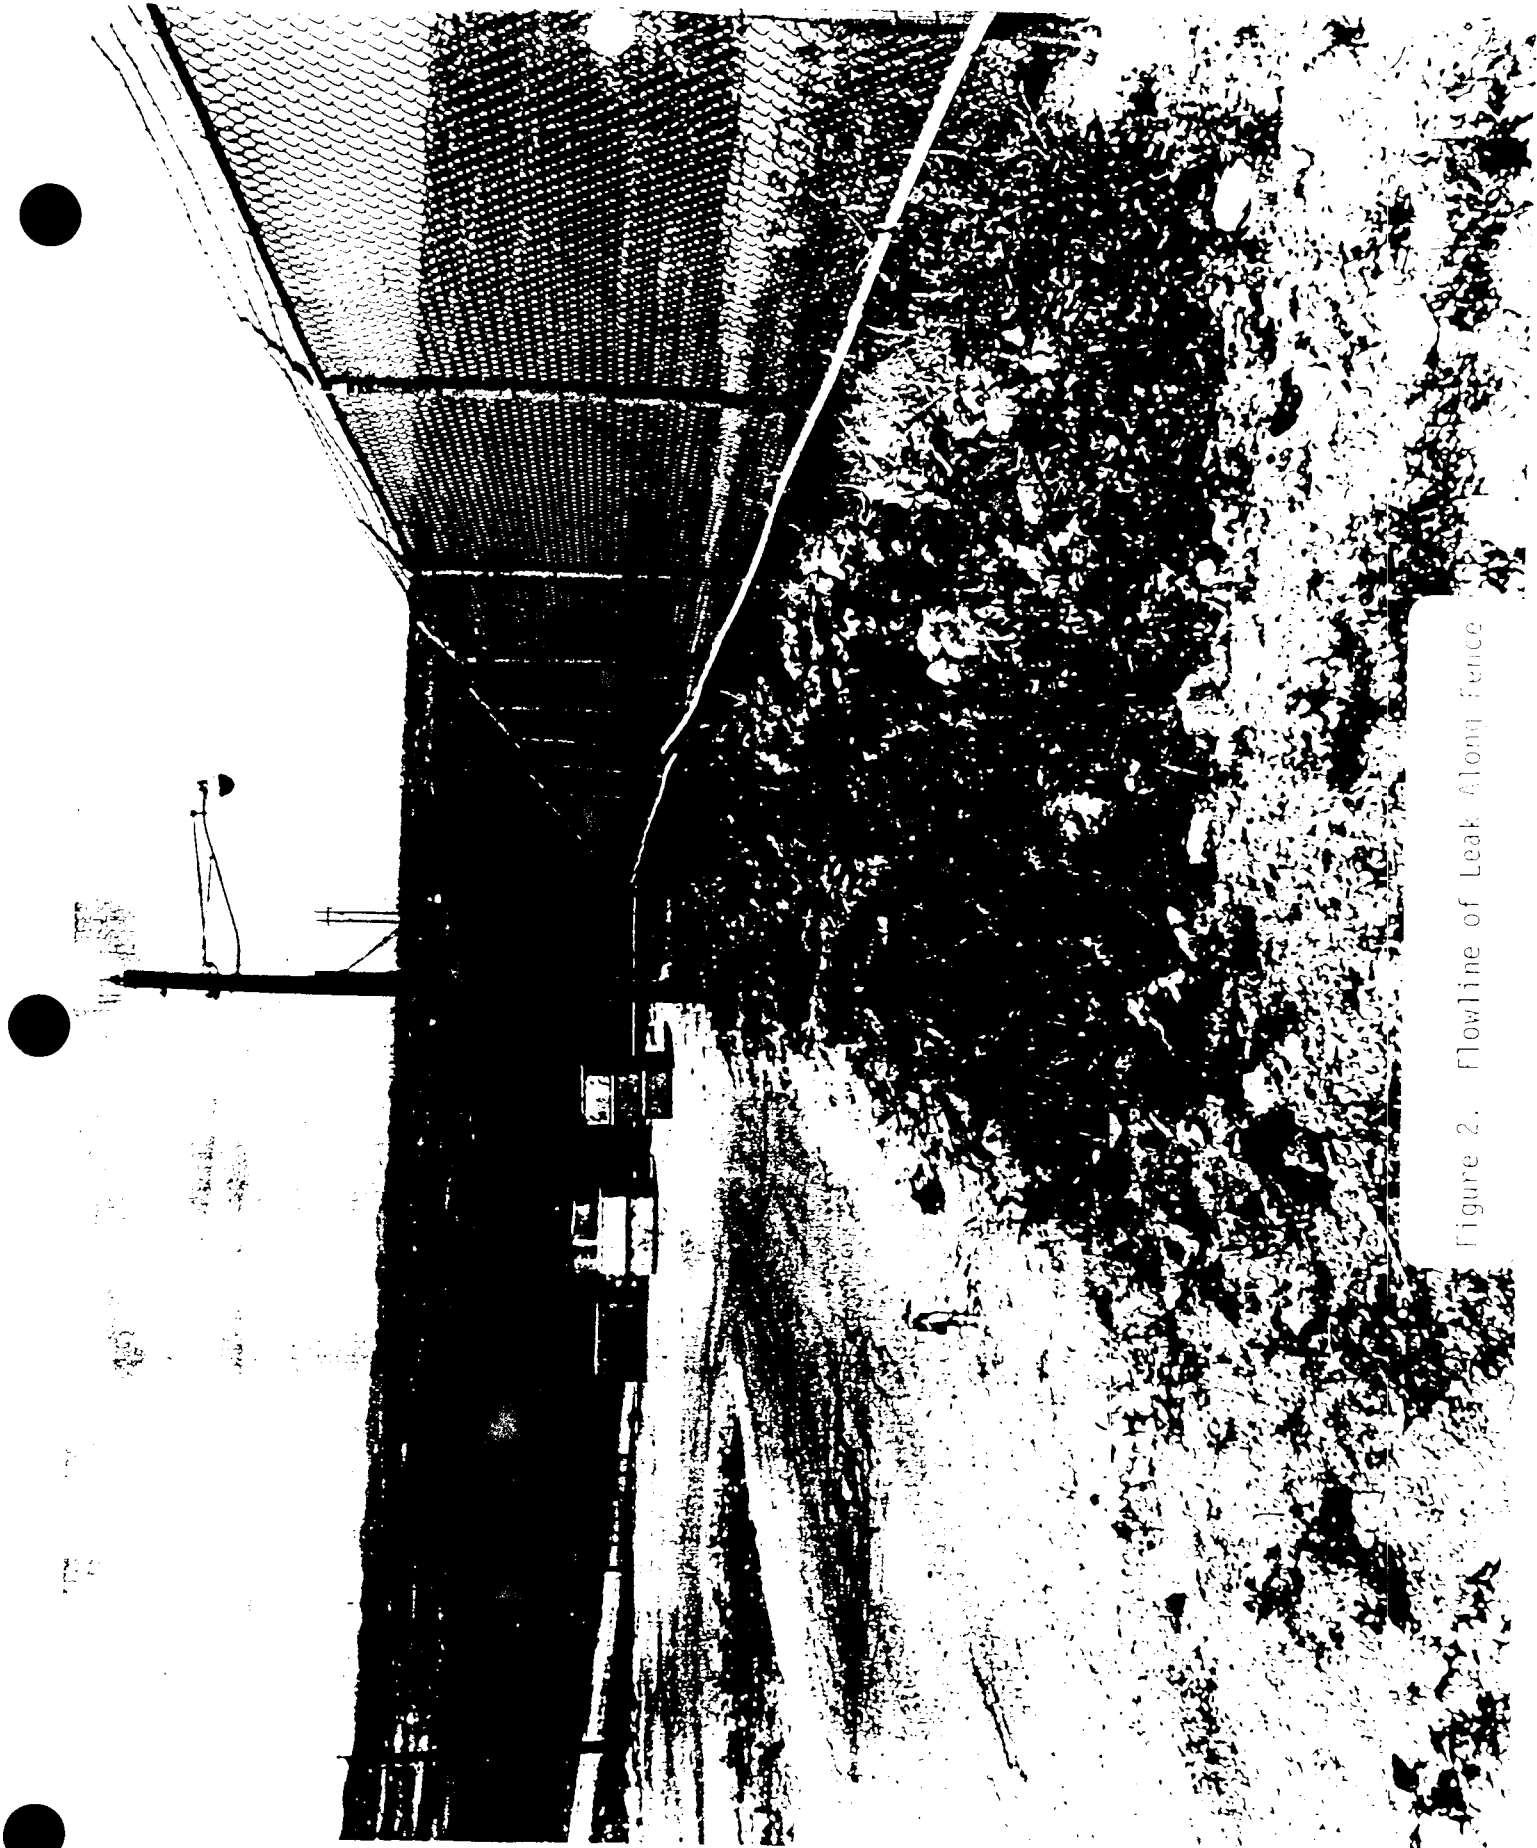
Figure 2. Flowline of Leak Along Fence

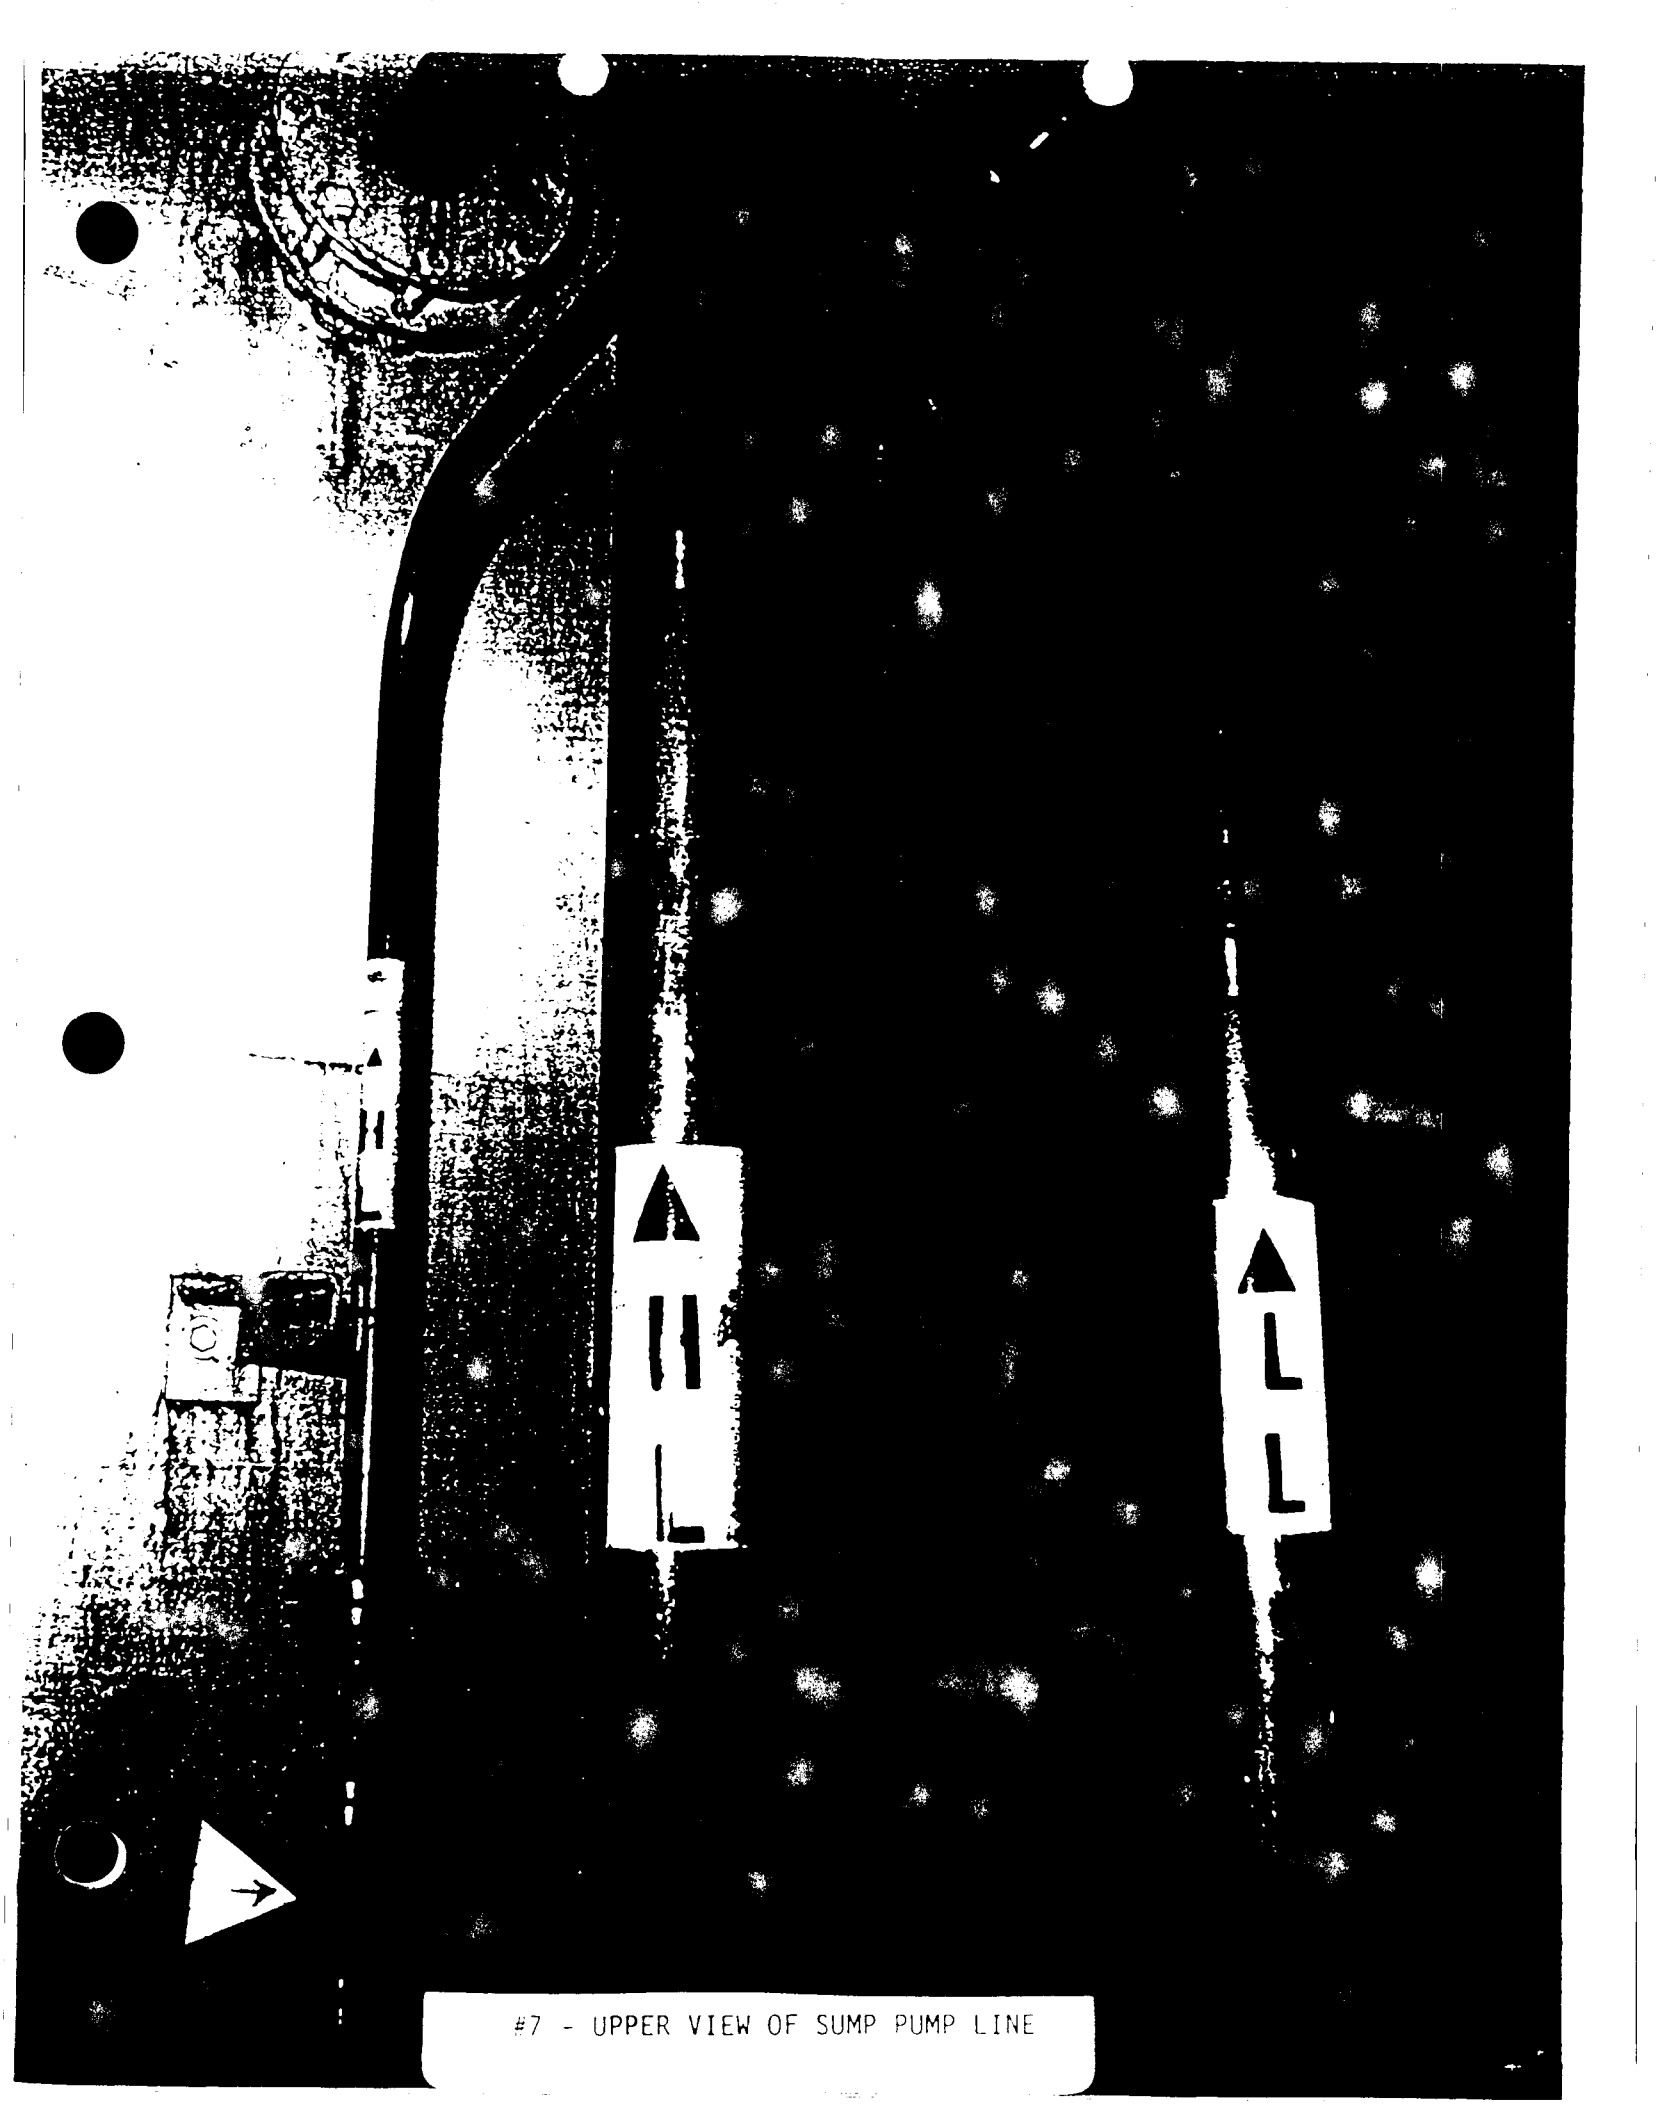
#7 - UPPER VIEW OF SUMP PUMP LINE
